Aging Performance of a Compliant Layer Bearing Acetabular Prosthesis in an Ovine Hip Arthroplasty Model

Abstract: The wear performance of a polyurethane compliant layer (CL) material formed into an acetabular component and implanted into a sheep model of cemented total hip arthroplasty was assessed at 6, 12, 24, and 48 months. Four (11%) of 36 acetabular components debonded from the cement and one component was slightly loose at the cement-bone interface. There was no macroscopic evidence of fracture, wear, or deformation of the CL material on the articular surface of the acetabular components. Small numbers of polymeric wear particles was found in the hip synovial tissues of 10 sheep, most commonly in the early time groups, and were likely associated with initial wear of surface asperities. The wear performance of the CL was unchanged during a 48-month implantation period. **Key words:** hip, arthroplasty, polyurethane, wear, in vivo.

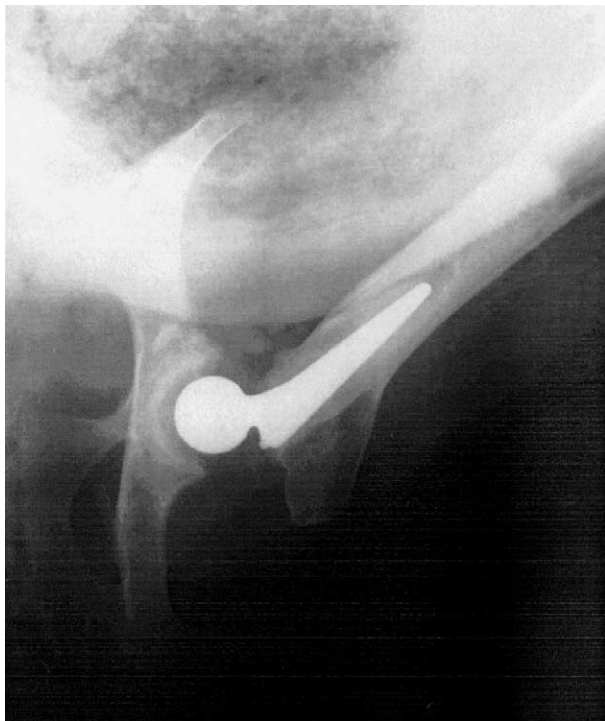
Fig. 1. Anteroposterior in vivo radiograph of a sheep hip implanted with the THA prosthesis that includes the Corethane CL acetabular component.

Left unilateral THA was performed on 36 skeletally mature Merino wether sheep (Fig. 1). Sheep were from one flock to minimize variation. Implant performance was assessed at 6, 12, 24, and 48 months. The first 8 arthroplasties performed were assigned to the 6-month group so that wear data were available early in the study to justify the longer term implantation of the CL system. The remaining sheep were randomized, using a random

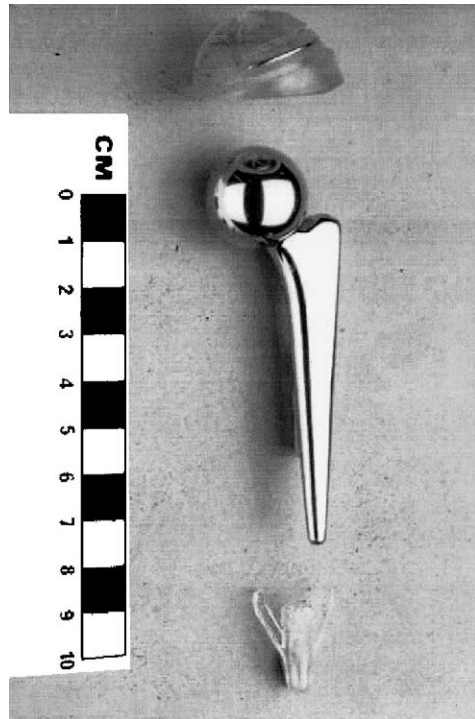
Fig. 2. Sheep THA prosthesis comprising a Corethane CL acetabular component, a stainless steel double-taper femoral component, and a plastic centralizer.

The CL acetabular components were formed by injection molding a 1.6-mm Corethane 80A polyurethane resin, forming the CL bearing surface, onto a Corethane 75D hard polyurethane backing (Howmedica Inc, Limerick, Ireland; Fig. 2). The CL acetabular component had a 15° hood. The nonarticulating component backing incorporated 4 radial grooves, 12 mm in length and 1.5 mm in depth, as well as 2 circumferential grooves extending for two thirds of the circumference at that level. The grooves were included to aid cement fixation. The outside and inside diameters of the CL acetabular component were 32 and 22.6 mm, respectively. The femoral stem was a scaled-down version of the modular polished double-taper Exeter stainless steel femoral stem (Howmedica Inc, Rutherford, NJ). The femoral component had a stem length of 71 mm and a modular 22.2-mm

femoral head with a 16-mm head offset (Fig. 2). This provided a radial bearing clearance of 0.2 mm between the head and the acetabular component.
